New Hampshire Volunteer Lake Assessment Program

2002 Interim Report for Partridge Lake Littleton

Partridge Lake, Littleton

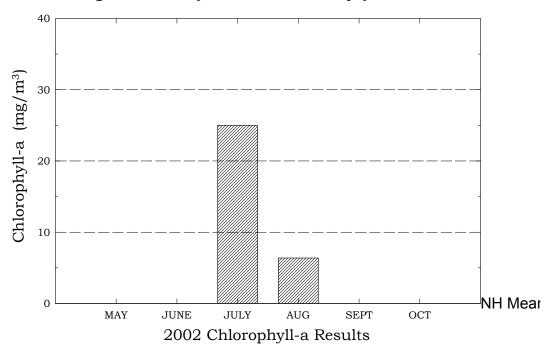
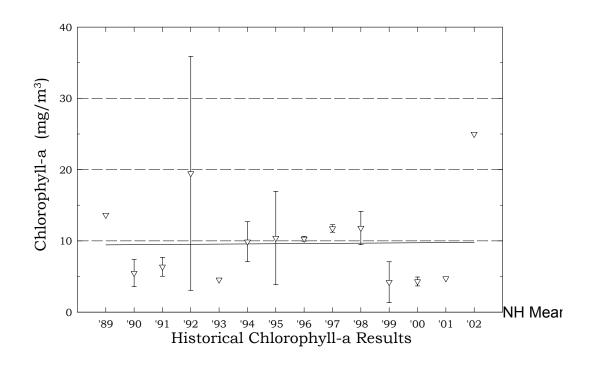
Figure 1. Monthly and Historical Chlorophyll-a Results

Figure 1 and Table 1: The graphs in Figure 1 (Appendix A) show the historical and current year chlorophyll-a concentration in the water column. Table 1 (Appendix B) lists the maximum, minimum, and mean concentration for each sampling season that the lake has been monitored through the program.

The chlorophyll-a concentration **decreased greatly** from the July to August sampling event. In July, the concentration was **much greater** than the state mean, but in August the concentration was **slightly less** than the state mean.

The historical data (the bottom graph) shows that the 2002 chlorophyll-a mean is **greater than** the state mean. It is important to point out that the mean annual chlorophyll-a concentration this summer is the **highest** annual mean since monitoring began. This is due to the **elevated** concentration in July.

Overall, visual inspection of the historical data trend line (the bottom graph) shows a *variable* in-lake chlorophyll-a trend, meaning that the concentration has *fluctuated* since monitoring began in 1989.

While algae are naturally present in all lakes/ponds, an excessive or increasing amount of any type is not welcomed. In freshwater lakes/ponds, phosphorus is the nutrient that algae depend upon for growth. Therefore, algal concentrations may increase when there is an increase in nonpoint sources of nutrient loading from the watershed, or in-lake sources of phosphorus loading (such as phosphorus releases from the sediments). It is important to continually educate residents about how activities within the watershed can affect phosphorus loading and lake quality.

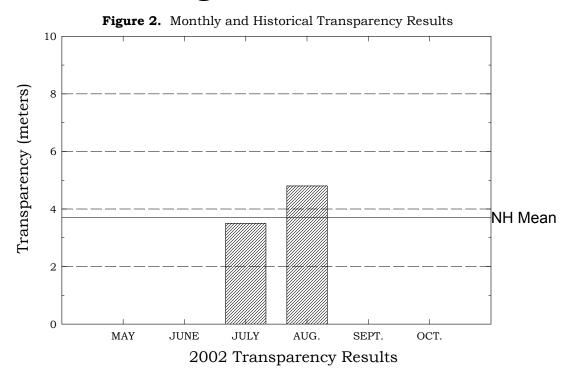
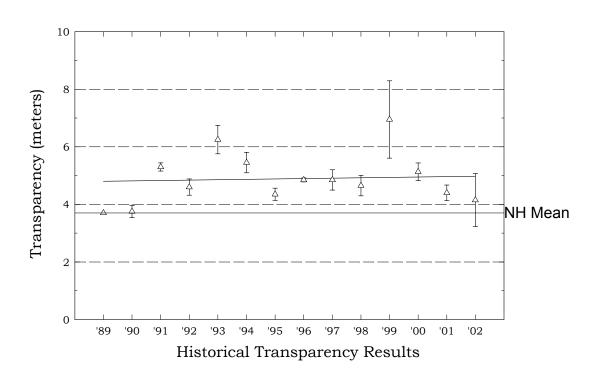
Figure 2 and Table 3: The graphs in Figure 2 (Appendix A) show historical and current year data for lake/pond transparency. Table 3 lists the maximum, minimum and mean transparency data for each sampling season that the lake/pond has been monitored through the program.

The transparency *increased* by approximately 1.5 meters from the July to August sampling event this season. It is interesting to note that as the chlorophyll-a concentration *decreased* from July to August this season, the transparency *increased*. We typically expect this inverse relationship in lakes. As the concentration of algal cells in the water column decreases, the transparency increases.

The historical data (the bottom graph) shows that the 2002 mean transparency is **greater than** the state mean. Overall, visual inspection of the historical data trend line (the bottom graph) shows a **variable** trend for in-lake transparency, meaning that the transparency has **fluctuated** since monitoring began.

Typically, high intensity rainfall causes erosion of sediments into the lake/pond and streams, thus decreasing clarity. Efforts should continually be made to stabilize stream banks, lake/pond shorelines, disturbed soils within the watershed, and especially dirt roads located immediately adjacent to the edge of tributaries and the lake/pond.

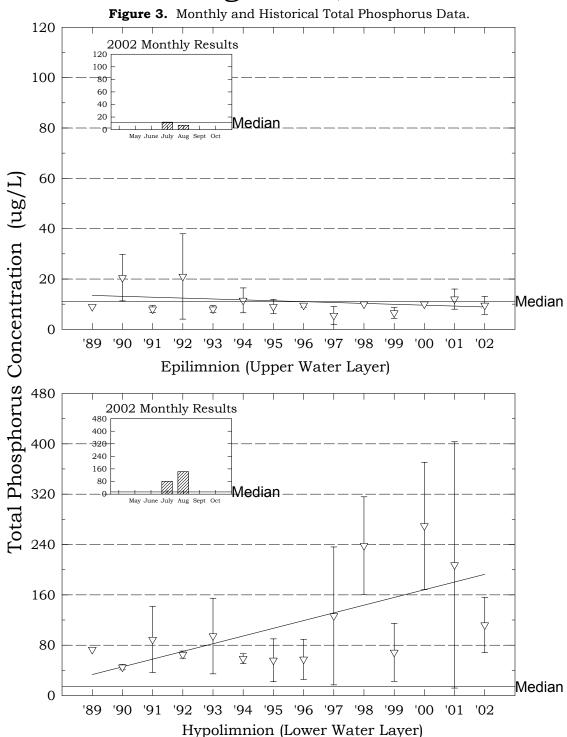
Figure 3 and Table 8: The graphs in Figure 3 (Appendix A) show the amounts of phosphorus in the epilimnion (the upper layer) and the hypolimnion (the lower layer); the inset graphs show current year data. Table 8 (Appendix B) lists the annual maximum, minimum, and median concentration for each deep spot layer and each tributary since the lake has joined the program.

The historical data for the epilimnion (upper layer) show that the 2002 total phosphorus mean is **approximately equal to** the state median. Overall, visual inspection of the historical data trend line for the epilimnion shows **a relatively stable** total phosphorus trend, which means that the concentration has **remained approximately the same** (**and slightly less than the state median**) in the epilimnion since monitoring began.

The historical data for the hypolimnion (lower layer) show that the 2002 total phosphorus mean is **much greater than** the state median. Overall, the historical data trend line for the hypolimnion shows a **fluctuating**, **but overall increasing**, total phosphorus trend, which means that the concentration has **worsened** in the hypolimnion since monitoring began in 1989. However, it is worthy to note that within the hypolimnion the total phosphorus mean has significantly decreased in the past two years. We hope that this trend will continue to occur.

One of the most important approaches to reducing phosphorus loading to a waterbody is to continually educate watershed residents about its sources and how excessive amounts can adversely impact the ecology and value of lakes and ponds. Phosphorus sources within a lake or pond's watershed typically include septic systems, animal waste, lawn fertilizer, road and construction erosion, and natural wetlands. If you would like to educate watershed residents about how they can help to reduce phosphorus loading into the lake/pond, please contact the VLAP Coordinator.
